EC11-005a

December 8, 2011

## 2007 – 2008 G35, 2008 EX35 AND 2009 – 2010 FX35; ENGINE HESITATION OR STOPS RUNNING AT IDLE OR VERY LOW SPEEDS

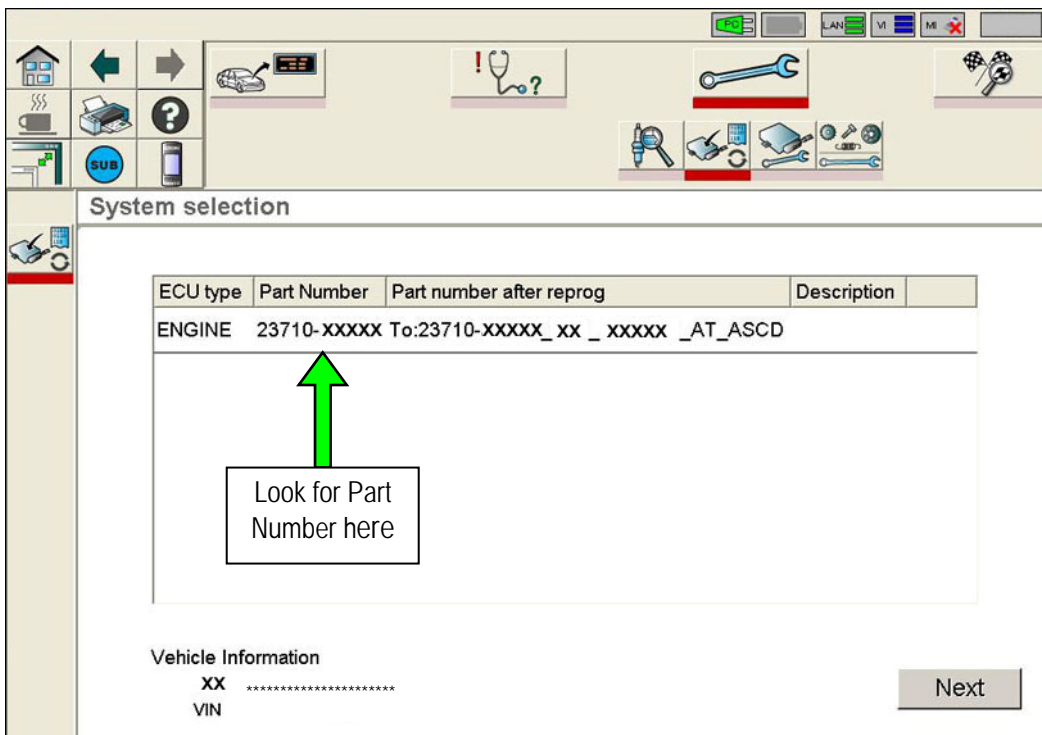
2. When you get to the ECM Reprogramming screen shown in Figure 1, confirm this bulletin applies as follows:

- A. On your C-III screen, look at the **Part Number** column (see Figure 1 example).

- If this column is **blank** (no part number listed), this **bulletin does not apply.**
- If a Part Number is listed, write it on the Repair Order and then go to Step B.

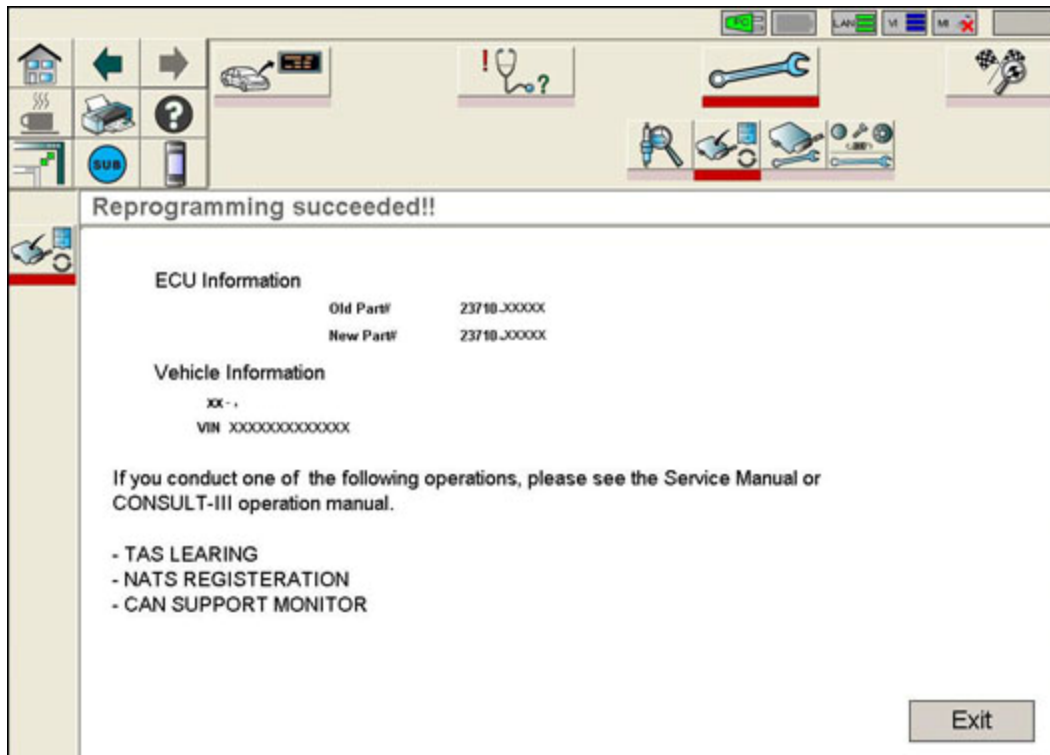
3. If this bulletin applies and you have performed ECM reprogramming, the screen in Figure 2 displays when reprogramming is complete.

**NOTE:** If the screen in Figure 2 does not display (reprogramming does not complete), click [here](#). This links to the ECM Reprogram Interruption Recovery General Procedure.
