Classification:
 EL07-013a

2007 G35; VOICE RECOGNITION ISSUES

APPLIED VEHICLES: 2007 G35 Sedan (V36) with Navigation System Equipment Only
APPLIED VINS: Vehicles built before: JNKBV61E(*)7M720823
 Vehicles built before: JNKBV61F(*)7M816642
APPLIED DATES: Vehicles built before: March 23, 2007

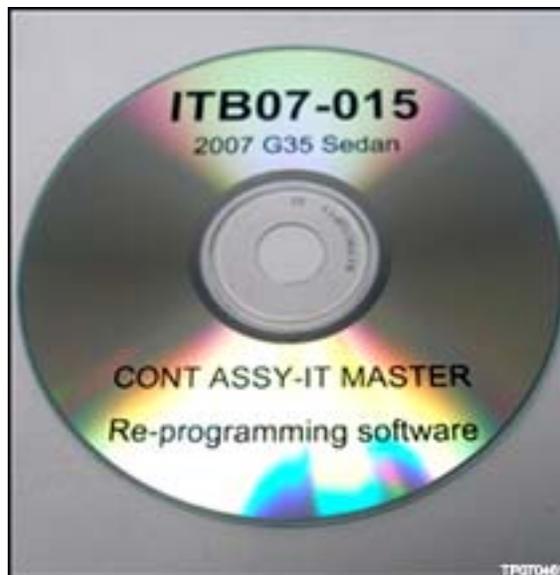
Figure 1

Voice tags are not recognized or have been deleted.

Voice recognition will not recognize 7 digit phone numbers.

Voice recognition is not accurate.

- Load and install the software update CD. See Figure 1.
- Refer to the Service Procedure in this bulletin for installing the new software.
