Classification:
Reference:
Date:

BT07-004

February 20, 2007

2005 – 2006 G35 COUPE; TEAR IN DRIVER'S SEAT CUSHION TRIM

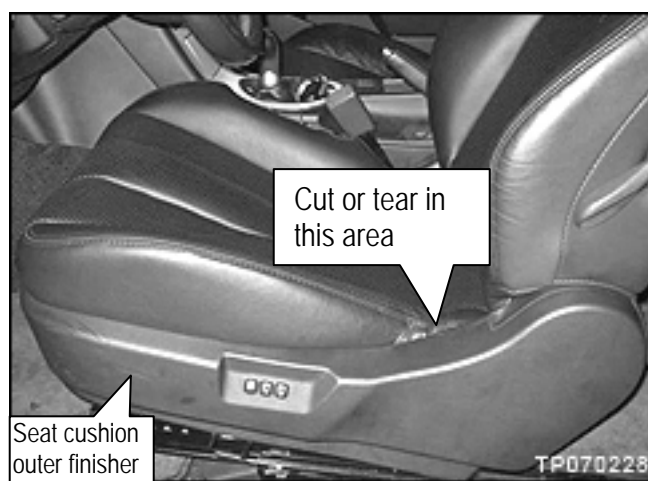
Figure 1

There is a cut or tear in the driver's seat cushion trim in the area shown in Figure 1.

Replace the seat cushion trim. Refer to section SE in the Service Manual for replacement information.

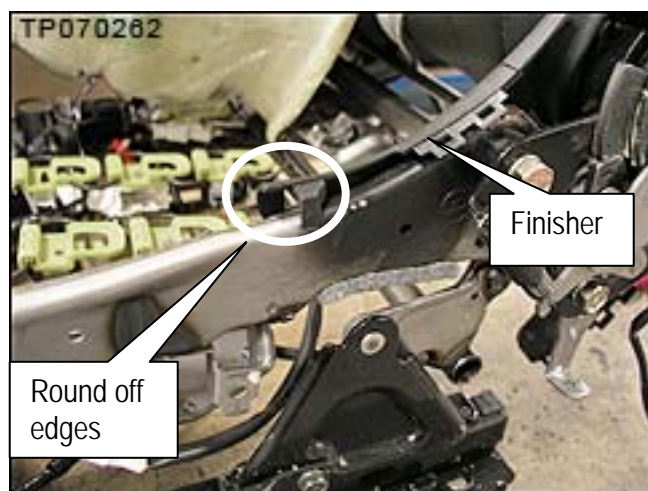
Figure 2

The sharp edges on the finisher may have caused the trim damage.

- While the seat cushion trim is removed, use a file (or other suitable tool) to "round" the front edges of the finisher shown in Figure 2.

- Use 2 new clips when reinstalling the seat cushion outer finisher.

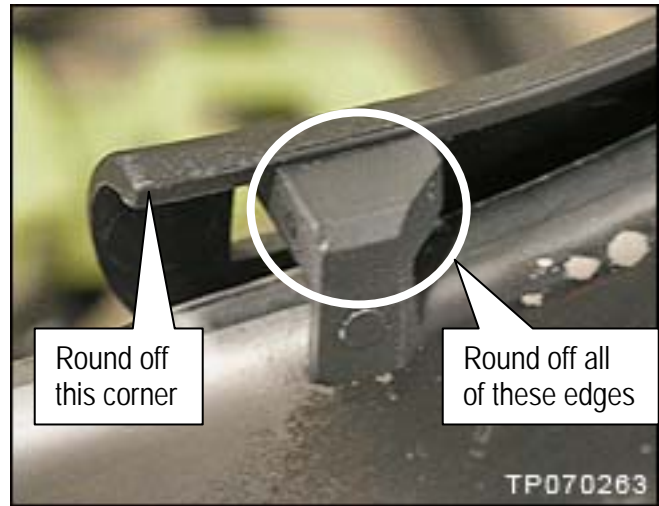
Figure 3

Before Rounding Edges

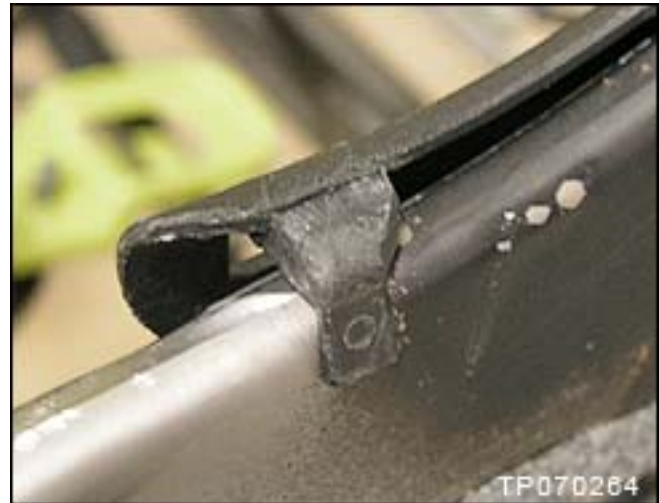
Figure 4

After Rounding Edges
