BT09-051

2007-2009 G SEDAN; DOOR OUTSIDE MOLDING(S) COMING APART

APPLIED VEHICLE: 2007-2009 G Sedan (V36)

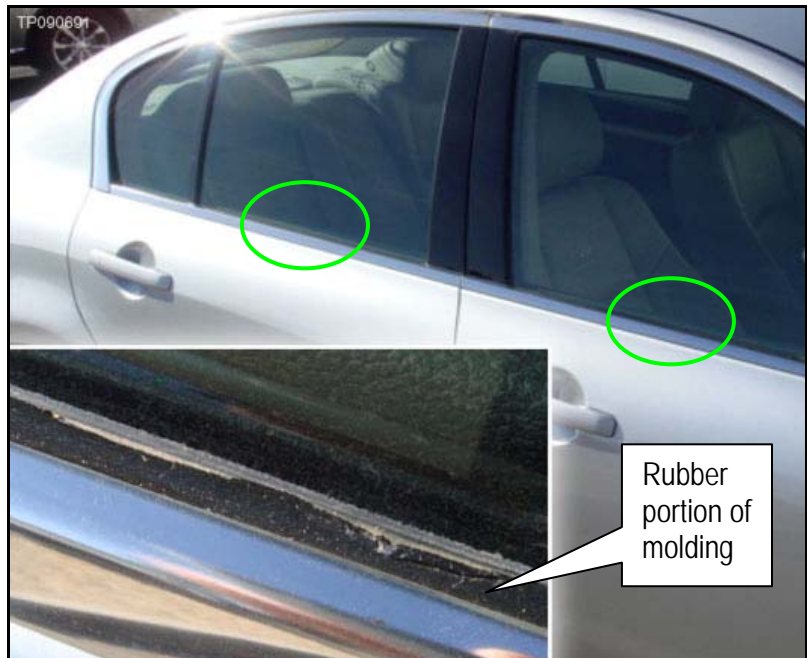
The rubber portion of a door outside molding(s) on an Applied Vehicle is coming apart and/or transferring black rubber material when touched.

Replace all four (4) door outside moldings with the ones listed in the Parts Information section.

- Refer to the "EXT" section in the applicable Electronic Service Manual (ESM) for removal/installation instructions.
