Classification:
 BT07-014a

G35 SEDAN / COUPE, FX, AND M; SUNROOF LID SEAL

APPLIED VEHICLE(S): 2005 - 2008 G35 Sedan (V35 and V36)
 2005 - 2007 G35 Coupe (CV35)
 2005 - 2008 FX (S50)
 2006 - 2008 M45 (Y50)

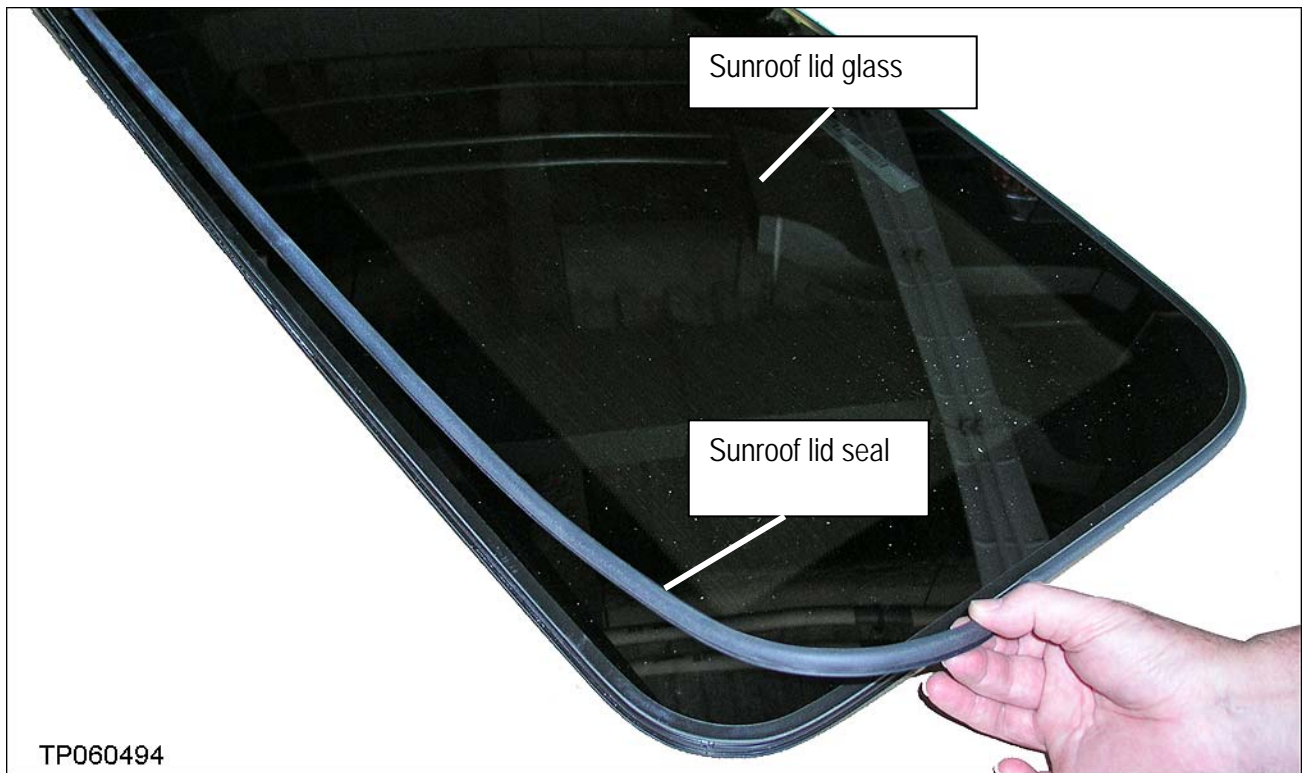
Figure 2

3. Remove the old sunroof lid seal.

- Just pull it off.

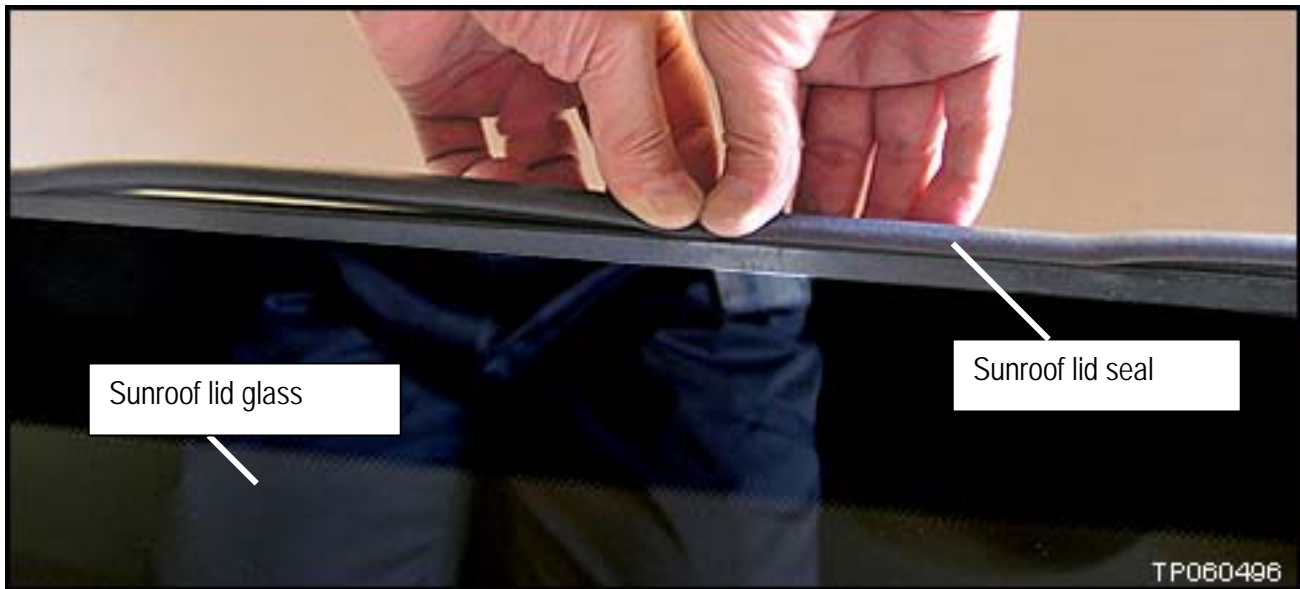
Figure 3

4. Install the new seal.

- Stretch the seal around the sunroof lid.
- Push the seal into the “ditch” (channel).
- Make sure the seal is pushed all the way into the ditch—no lifted areas.

NOTE: If needed, very light taps with a rubber hammer can be used to press the seal into the “ditch”.
